COUNTY OF MILWAUKEE
Behavioral Health Division Administration
INTER-OFFICE COMMUNICATION

SUBJECT: **From the Director Department of Health and Human Services, providing an informational report regarding the Department's intent to close the Behavioral Health Division Center for Independence and Development (formerly Hilltop) and Rehabilitation Center Central and to relocate residents to integrated community settings – A Mental Health Redesign Effort**

CBRE

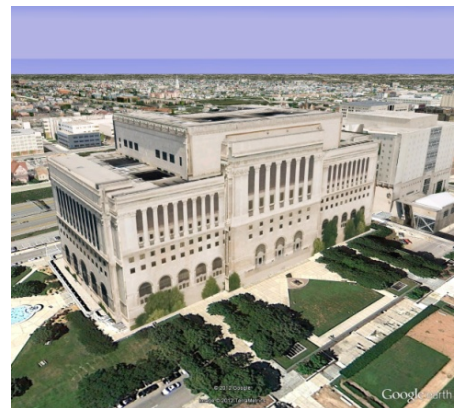
Courthouse

- Background Data
 - Square Feet: 1,021,000
 - Year Built: 1932
- Overall Building Condition
 - The courthouse has a substantial need for building upgrades throughout including HVAC, lighting, electrical, windows, signage and interior finishes

- Capital projects are being carried out on an ongoing basis (steam controls, windows, façade repair, etc.) but often in small increments such as the replacement of windows

- Functionality and utilization can be improved with through an assessment of storage practices, underutilized space and a move toward the implementation of revised space standards as spaces are remodeled.

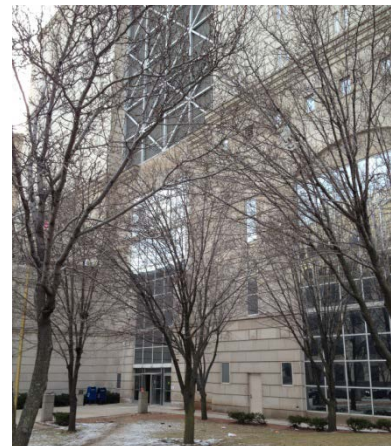
Criminal Justice Facility

- Overall the building is in good condition, however, many of the HVAC system components are nearing the end of their useful life and will need to be replaced
- While this is a relatively new facility, it shares the same lack of routine maintenance scheduling that is apparent in older facilities

- **Major Capital Requirements**
 - Upgrades to HVAC, domestic water and electrical components is recommended
- **Safety**
 - The fire alarm system while still in good condition, should eventually be upgraded to be coordinated with the court house system.

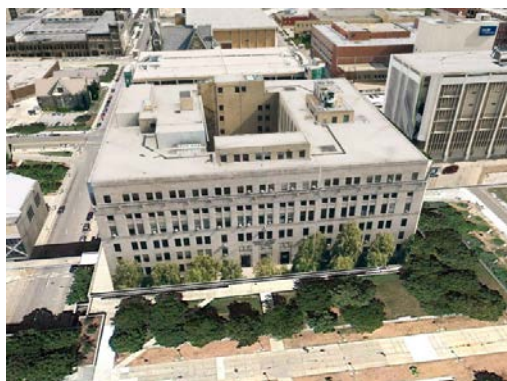
Safety Building

- **Background Data**
 - Square Feet: 296,000
 - Year Built: 1928
- **Overall Building Condition**
 - A significant amount of area on each floor contains unoccupied former jail space, some of which is in poor condition and underutilized.
 - A portion on the third floor is scheduled to be renovated into office space, but the majority is unused.

- Corridors used for storage block egress paths
- Walls are opened up when pipes burst causing exposed asbestos which is abated at time of work but remaining condition is unsafe
- Exterior steps are deteriorating and handrails rusting could cause hand slivers, trips, etc.

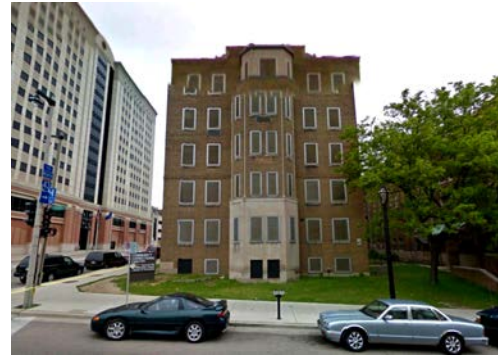
- Background Data
 - Square Feet: 75,544
 - Year Built: 1930's
- Overall Building Condition
 - Currently boarded up and not used
 - Crumbling concrete, rusted exterior railings and miscellaneous metal

- Functionality/ Utilization
 - Former St. Anthony's Hospital – Code violations caused "Huber" jail to close
 - Not currently functional for any County use

- Operational Issues
 - Abandoned
 - State inspectors have given the building 30 code violation citations
- Major Capital Requirements
 - Elevators, HVAC and other major components are old, out of service and would need to be totally replaced

- Safety
 - Deterioration of the building is a major safety issue
- Highest & Best Use
 - Vacant land value
 - Should be zoned for uses compatible with the court house area uses

- Summary
 - The existing building should be demolished
 - The remaining vacant parcel may be used for parking, court consolidation or related County functions or it could be sold. We recommend holding until details of Core Campus plan are finalized.

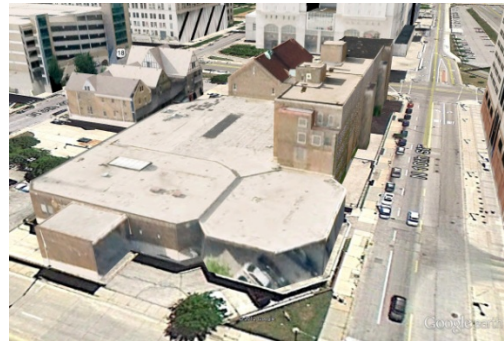
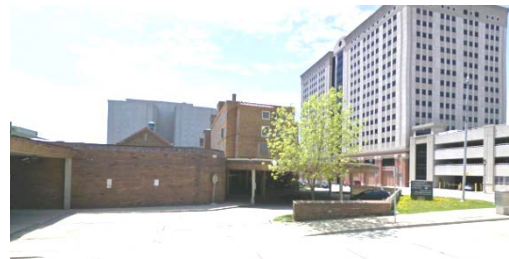
Medical Examiner

- The property has deferred maintenance issues including a need for masonry repair, deteriorating walks/driveways, open ceiling tiles due to pipe leaks, air conditioning breakdowns, basement water damage from a roof leak (now repaired) and water damage and corrosion around walls and window/door frames.
- Interior surface finishes are modest but in good repair
- Leaking roof problems have been repaired for now

- All major HVAC, electrical and plumbing systems should be upgraded or replaced

- Overall building deterioration including water damage from a roof leak (now repaired) and aging systems create air-borne hazard issues from mold and pest infestation
- Corridors use for storage create exiting hazard
- Exterior step deterioration creates a trip hazard

- Building should be demolished
- County should consider combined facilities with city and state operations

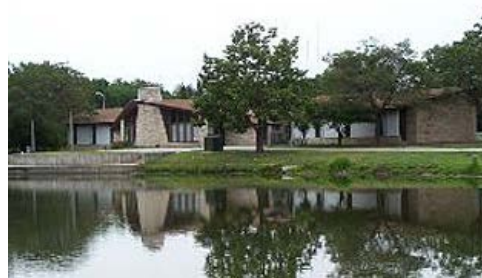
McGovern Park Senior Center

- Overall the building is in good condition, but deferred maintenance items need to be addressed before they create larger problems

- Deferred maintenance items need to be scheduled and budgeted
- With repairs, this center should continue to serve as a senior center for many years

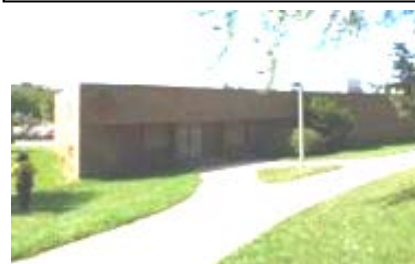
Rose Park Senior Center

- Overall the building is in good condition
- Many systems while functional are nearing the end of their useful life

- **Functionality/ Utilization**
 - Some restrooms are not ADA compliant
- **Operational Issues**
 - Many systems while operational are nearing the end of their useful life
- **Major Capital Requirements**
 - Primarily to upgrade systems
 - Exterior maintenance issues include walkways, front entrance, leaking roof and tuckpointing
- **Safety**
 - Exit doors need panic hardware
 - Some exits are locked all day
- **Highest & Best Use**
 - Continued use as a senior center
- **Summary**
 - Deferred maintenance items need to be scheduled and budgeted
 - With repairs, this center should continue to serve as a senior center for many years

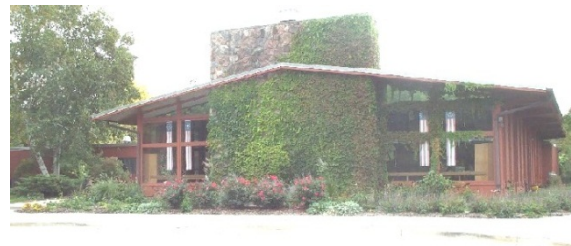
Wil-O-Way “U” Recreation Center

- Background Data
 - Square Feet: 8,975
 - Year Built: 1964
- Overall Building Condition
 - Overall the building is in good condition.
- Functionality/ Utilization
 - Adequately serves the functions of the Department of Family Care
 - Provides 3rd party rental income
- Operational Issues
 - Most HVAC components were recently upgraded
 - Electrical upgrades to lighting fixtures would save energy
- Major Capital Requirements
 - Portions of the building have been remodeled
 - Some deferred maintenance and systems lifecycle replacement issues
- Safety
 - Cracked curb/sidewalk trip hazards
- Highest & Best Use
 - Continued use as a multi-use park facility
- Summary
 - Deferred maintenance items need to be scheduled and budgeted
 - With repairs, this center should continue to serve as a multi-use park facility for many years

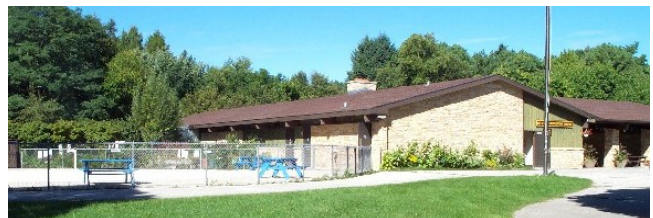
Wil-O-Way “G” Recreation Center South

- Background Data
 - Square Feet: 10,509
 - Year Built: 1981
- Overall Building Condition
 - Overall the building is in good condition
 - Recently installed three season room, kitchen cabinets and roof
- Functionality/ Utilization
 - Works well for party rentals and events
 - Generates 3rd party revenue from Goodwill operated adult day care

- Operational Issues
 - Adequately serves the recreational and adult day programs it services
- Major Capital Requirements
 - Exterior maintenance includes painting and door and window repairs
 - Heating and air handling units are beyond their useful life
- Safety
 - Main water service is next to electrical service equipment
 - Need to monitor effectiveness of fire alarm system
- Highest & Best Use
 - Continued use as a multi-use park facility
- Summary
 - Schedule deferred maintenance repairs
 - Continue to operate as a multi-use park facility

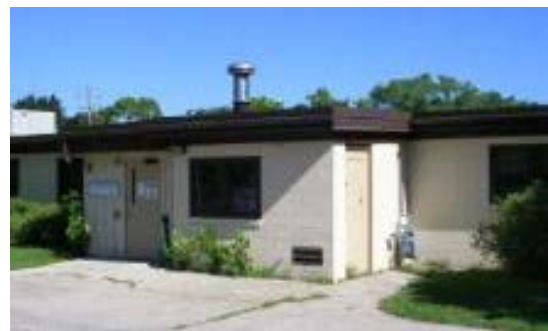
Kelly Nutrition Center

- Background Data
 - Square Feet: 4,290
 - Year Built: 1955
- Overall Building Condition
 - Built as barracks housing, the concrete block/wood joist structure was not intended for long term use

- Door hardware is not ADA compliant

- Major Capital Requirements
 - Need to replace hot water, heating, air conditioning and ventilation equipment
 - Wood windows need replacement
- Safety
 - Separate buildings hampers safe navigation between buildings during winter months, security all year
 - No stoops at exterior doors causes pavement settlement at door thresholds
 - Older wood double-hung windows are heavy and difficult for elderly to open. Could drop and cause injury
- Highest & Best Use
 - Building need substantial repairs and is poorly laid out to service elderly users
 - Need to question making required repairs or replacing facility
- Summary
 - Recommend demolishing structure and consolidation of the senior center and nutrition center in a new facility possibly as part of a development structure that gives a private operator incentives to build. Need to coordinate with Parks Department.

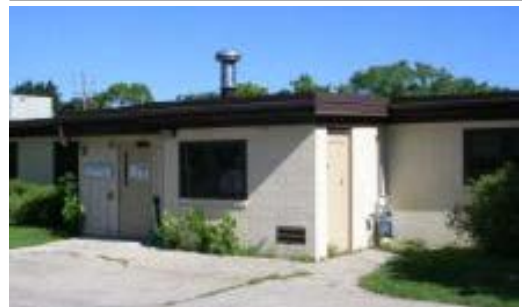
Kelly Senior Center

- Background Data
 - Square Feet: 10,300
 - Year Built: 1954
- Overall Building Condition
 - Built as barracks housing, the concrete block/wood joist structure was not intended for long term use
 - The building is constructed of block walls, wood joist roof, wood doors and windows which are thermally inefficient to meet today's energy standards. It has had minimal maintenance and thermal upgrades.
- Functionality/ Utilization
 - There is no curb appeal or amenities that would attract more users given the age and aesthetics of this building.
 - Large underutilized corridors reduce useable square footage
- Operational Issues
 - Two building layout including two kitchens, makes it difficult for staff and users to traverse outside between buildings especially in inclement weather.
 - Door hardware is not ADA compliant

- Major Capital Requirements
 - Deferred maintenance items need to be scheduled for repair or replacement
- Safety
 - Separate buildings hampers safe navigation between buildings during winter months, security all year

- No stoops at exterior doors causes pavement settlement at door thresholds
 - Older wood double-hung windows are heavy and difficult for elderly to open. Could drop and cause injury

- The local Fire Inspector requested a second means of egress be provided in large hall per building code requirements
- Highest & Best Use
 - Building need substantial repairs and is poorly laid out to service elderly users

- Need to question making required repairs or replacing facility
- Summary
 - Recommend demolishing structure and consolidation of the senior center and nutrition center in a new facility possibly as part of a development structure that gives a private operator incentives to build a combined senior center with elderly housing. Need to coordinate with Parks Department.

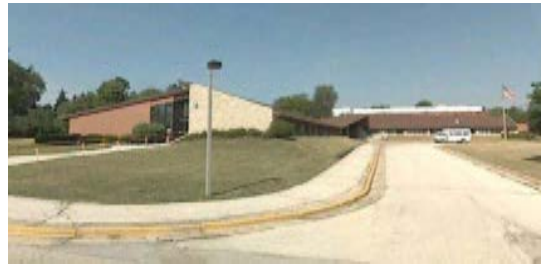
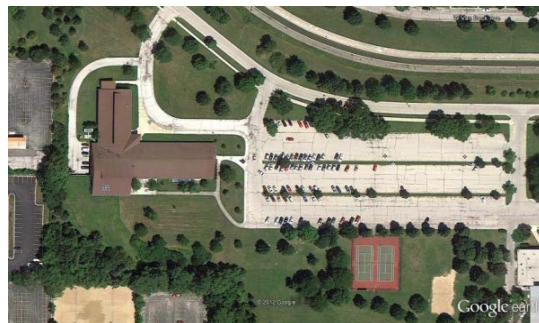
Wilson Park Senior Center

- Background Data
 - Square Feet: 38,458
 - Year Built: 1980
- Overall Building Condition
 - Overall the building is in good condition, however, some HVAC and plumbing components are nearing the end of their useful life
- Functionality/ Utilization
 - The building contains many amenities that that serve the needs of the senior citizens who use the facility
- Operational Issues
 - Many of the HVAC components are beyond their useful life
- Major Capital Requirements
 - Wood siding is coming loose in many locations
 - Need to schedule repair and replacement of selected building components

- Building does not have fire sprinklers
- Accessible curb ramp has been patched and is crumbling – does not meet today's code and design standards
- Exterior doors should have single action / secure type panic devices rather than push bars with thumb turn locks. Thumb turns are not easily unlocked during a panic situation which can cause delays in egress during emergency situations
- Curbs, sidewalks and asphalt are cracked and buckling causing trip hazards, especially at elderly facility

- Deferred maintenance items need to be scheduled and budgeted
- With repairs, this center should continue to serve as a senior center for many years

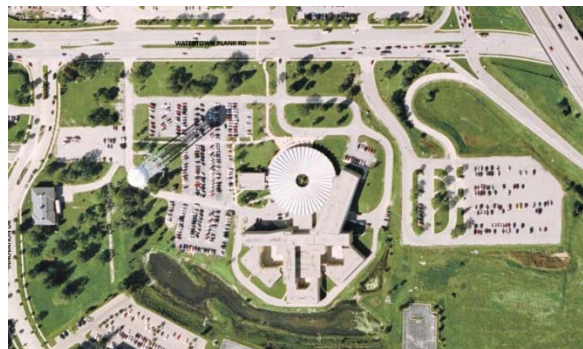
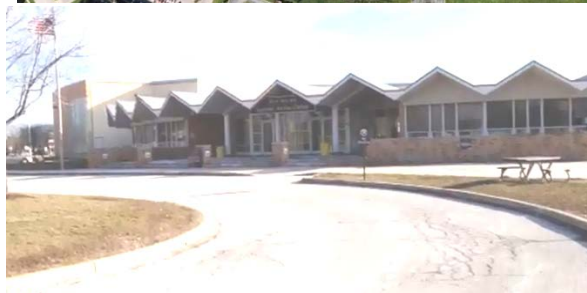
Vel Phillips Juvenile Justice Center

- Overall the building is in good condition

- Most of the deferred maintenance is cosmetic, however, major building systems need to be measured against their useful life and maintained accordingly.

- Exterior concrete walks uneven, trip hazards
- Spawling / falling concrete from underside of concrete overhangs
- Parking and pedestrian conflicts in parking lots
- Fire alarm system has a heat and routing problem and should be replaced

- The building is in relatively good condition and adequately serves the court function
- Longer term, the court function could be consolidated near the Courthouse. If the County develops a plan to consolidate this function, the property is should be marketable for a variety of commercial uses.

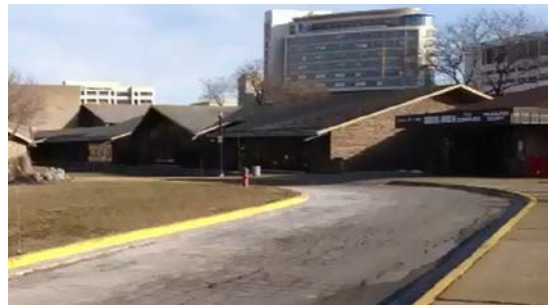
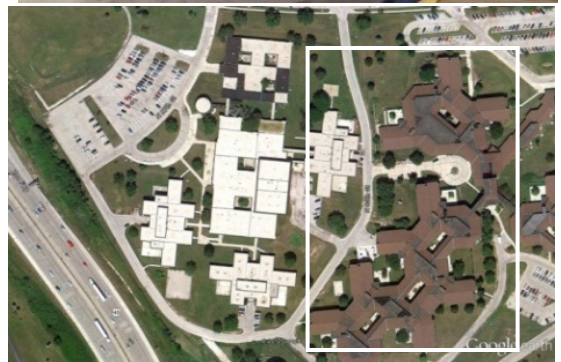
Mental Health Center

- Currently closing 24 beds and moving patients to community based facilities
- Need more private rooms in wards serving aggressive patients
- Higher than average utility costs

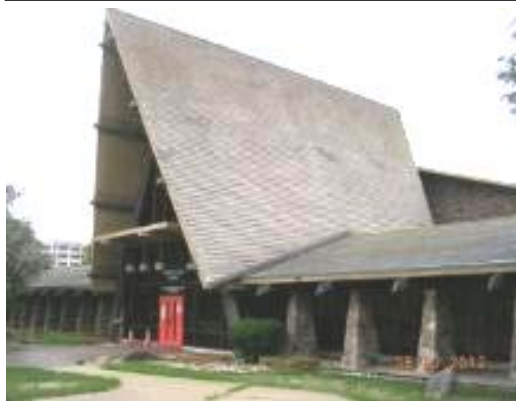
Day Hospital

- Background Data
 - Square Feet: 129,433
 - Year Built: 1968
- Overall Building Condition
 - Overall the building is in good condition but dated
 - Some water damage in the basement
- Functionality/ Utilization
 - No longer used as a day hospital
 - Rented out to private and non-profit groups for case management adolescent patient treatment
 - Use of recreation spaces has been abandoned or cut back due to shorter 7 day stays, down from 21 days
- Operational Issues
 - Rent from St. Charles was recently cut from \$35,000/ month to \$7,000/ month
 - Services provided at this location may be moved elsewhere

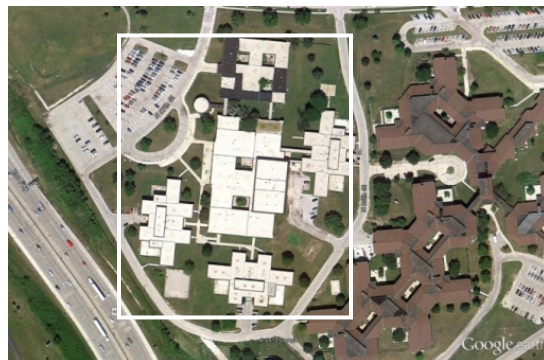
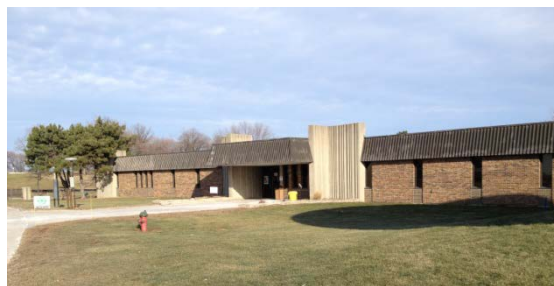
Child & Adolescent Treatment Center

- Background Data
 - Square Feet: 182,787
 - Year Built: 1973
- Overall Building Condition
 - The overall building condition is good, but it requires interior and systems upgrading
- Functionality/ Utilization
 - This property serves the Wauwatosa Schools, UW Extension and Milwaukee County EMS
- Operational Issues
 - No longer used for Adolescent Treatment, the property adequately serves the office uses
 - Many systems and interior finishes need to be upgraded
- Major Capital Requirements
 - HVAC systems beyond useful life
 - Sprinkler installation

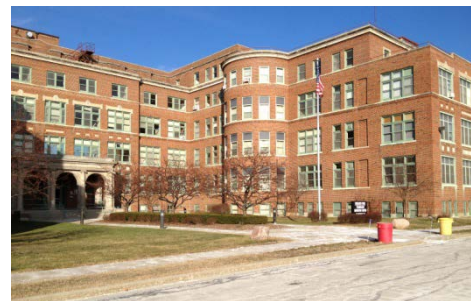
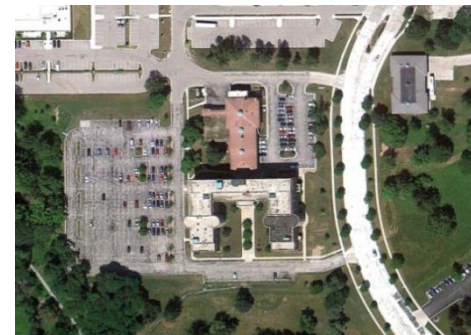
Technology Innovation Center

- The building will lose access to a steam line that services the boilers when the Watertown Plank/Highway 45 interchange is re-built. Boiler replacement will be expensive.
- Potential upgrades include the fire alarm system, plumbing fixtures, domestic hot water, new boilers, central air conditioning and exterior doors and windows.

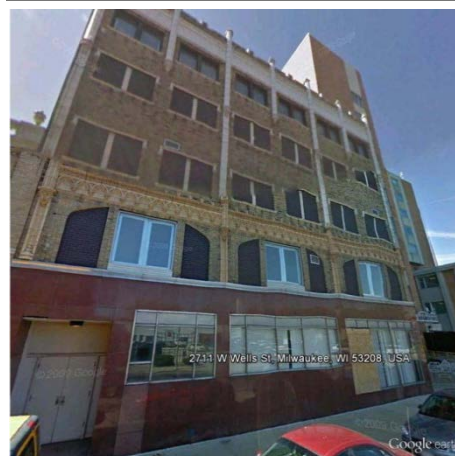
City Campus Office Complex – 5 Story

- Background Data
 - Square Feet: 28,025
 - Year Built: 1986
- Overall Building Condition
 - Overall building conditions are fair
- Functionality/ Utilization
 - The former hospital layout does not function well for office use
- Operational Issues
 - Very high cost to operate the building
- Major Capital Requirements
 - Extensive infrastructure upgrades required
- Safety
 - Asbestos in the building
 - Major deficiencies in fire protection system
 - Building lacks selected fire rated doors, dampers and penetration seals
- Highest & Best Use
 - Alternative redevelopment of the site should be tailored to the City of Milwaukee - Near West plan
- Summary
 - Demolish and sell

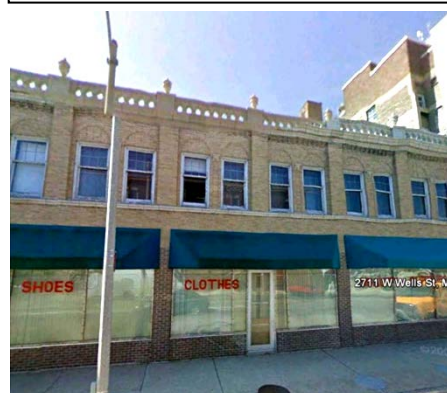
City Campus 27th Street Store Front

- Background Data
 - Square Feet: 19,366
 - Year Built: Not available
- Overall Building Condition
 - Operational with several existing leased storefronts
- Functionality/ Utilization
 - Serves the need of neighborhood retail
- Operational Issues
 - County should not be in the retail landlord business
